WATERSHED NEEDS ASSESSMENT

TAUGHANNOCK CREEK TOMPKINS COUNTY, NEW YORK

April 13, 2011

MMI #4395-01

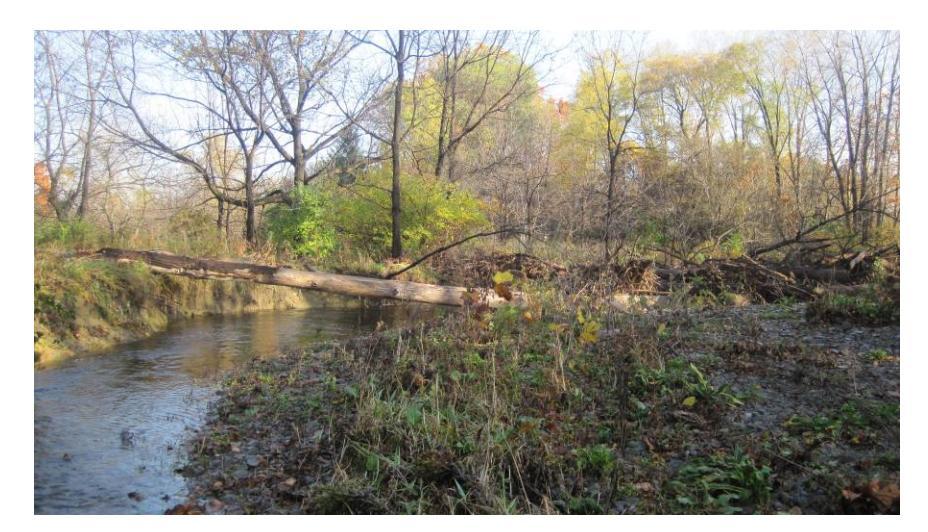
Photo 1: Apex of a meander bend near station 455+00. Note scour on the left bank and point bar formation on the right bank.

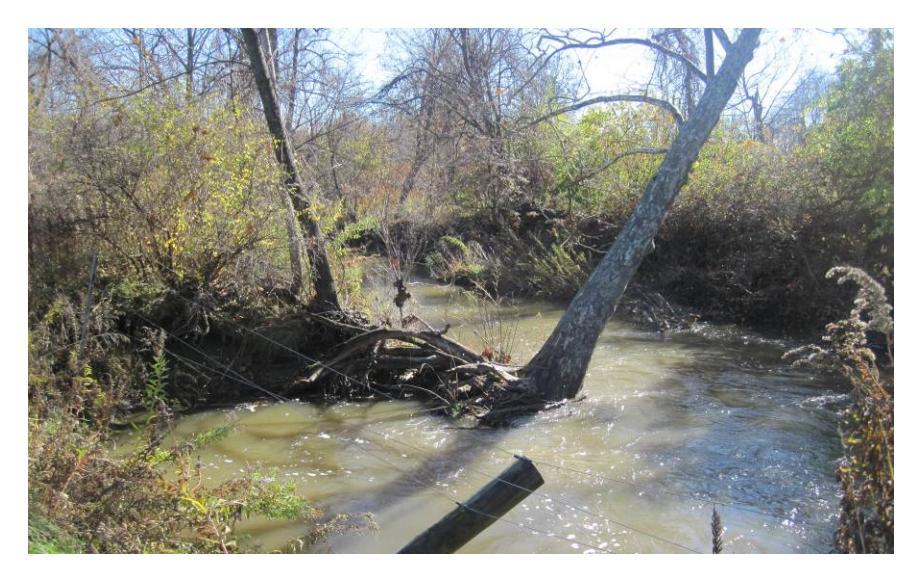
subwatershed). Photo 2 shows the turbid conditions at an eroding bank segment in Spring Brook.

Photo 2: Exposed clay in eroding bank segment and high turbidity conditions in Spring Brook near the Tompkins County line.

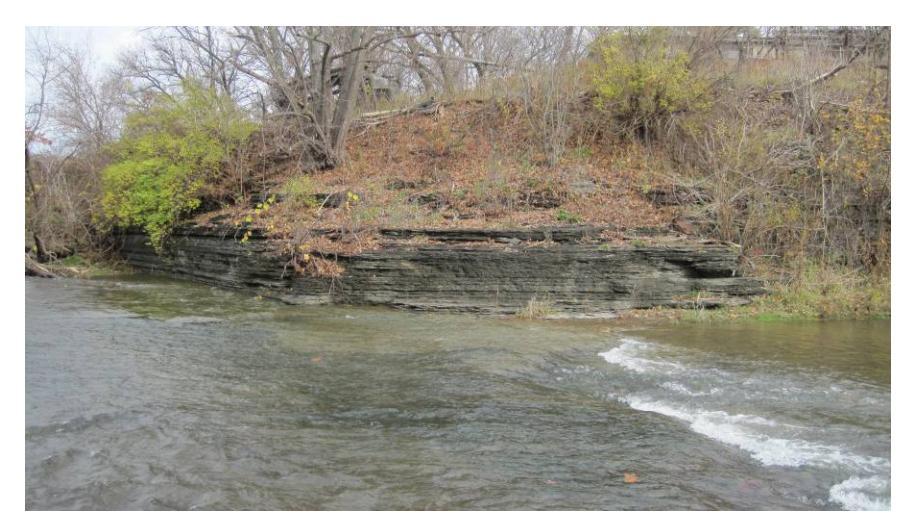
Photo 3: Exposed foliated shale bedrock in left bank and channel bed upstream of Waterburg Road Bridge.

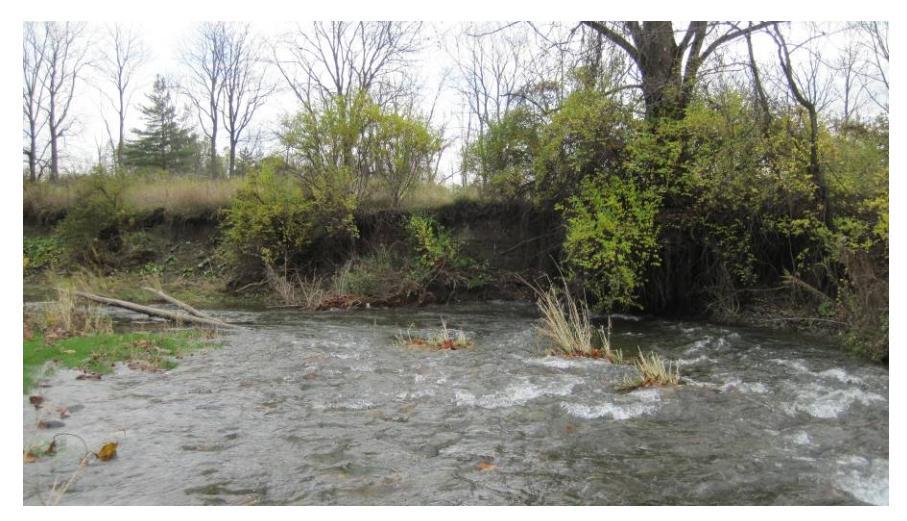
Photo 4: Eroding bank segment in a high bluff.

It is recommended that this river segment be further inspected for eroding banks that could be contributing fine sediments in the main channel, like the one pictured in Photo 4 above. These types of eroding banks can often be restored through natural bank stabilization techniques (a healthy riparian buffer, for example), or with instream techniques such as channel relocation or strategic placement of deflecting structures along the eroding bank.

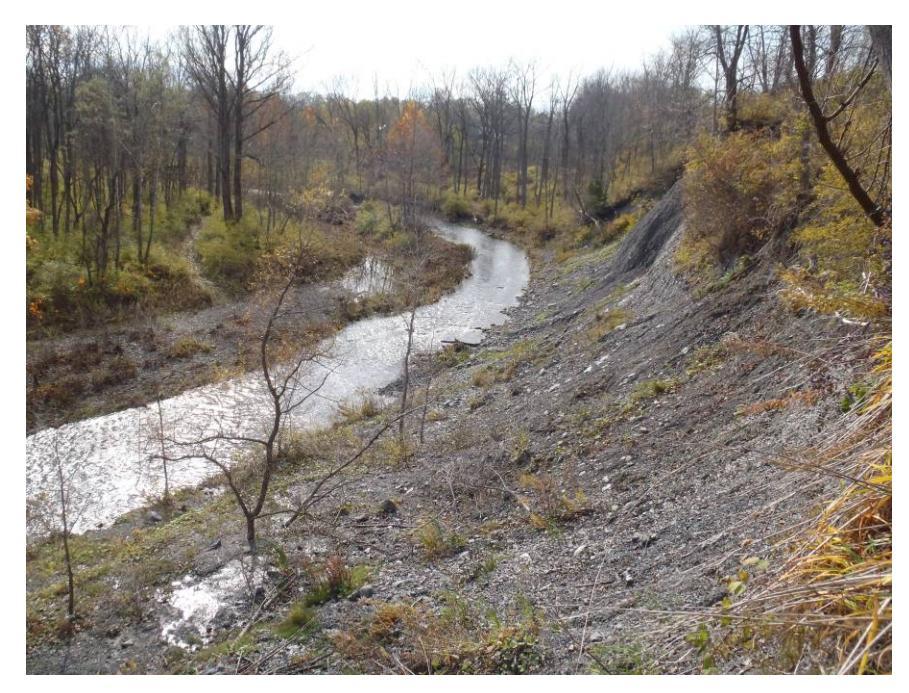
The South Street Extension escarpment (Photo 5) includes several geomorphic processes, including lateral channel migration into the toe of slope, toe erosion, and evidence of mass slope failure. The nearly barren face of the slope failure was measured at 58 feet high by 320 feet long, at a mean gradient of 122% (50 degrees). The upper 15 feet of the escarpment is near vertical, undercutting the root depth of mature hardwood, which periodically fail and fall. Ground water discharges were observed 10 to 15 feet below the top of ground. The soil consists of a clay-rich glacial till with moderate numbers of small stones but few cobbles. Neighborhood residents report that local water supply wells penetrated 120 feet of nearly impermeable clay soils. As a result, when slides occur, they do not provide enough coarse material to form a stable talus slope or to stop fluvial toe erosion. Only three- to 12-inch rocks were found at the toe.

Photo 5: Facing upstream at the downstream end of the South Street Extension bank failure site.

The escarpment angle exceeds the assumed gradient of glacial till soils (35 to 45 degrees) and is weakened by ground water; seeps were observed only three feet below the crown. An active storm drain also discharges onto the face at its upstream end. Further toe erosion and mass failures can be expected. See Section 6.0 for specific recommendations.

In between our October 2010 and March 2011 inspections, the top of bank near South Street Extension had another slope failure and receded about eight feet, and a fresh riverbank cut near the edge of water was also evident.

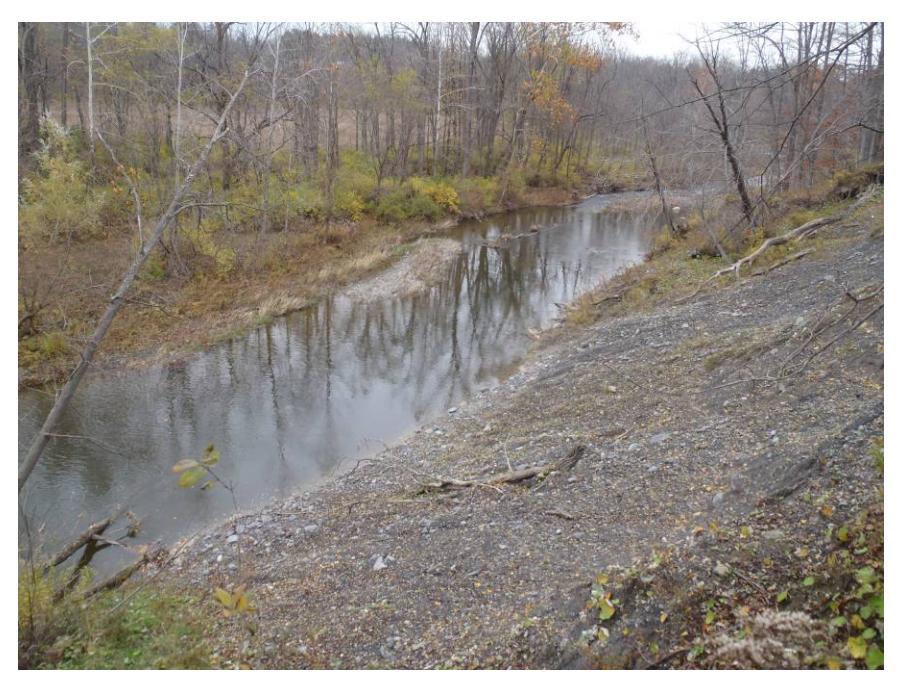
Two separate high valley wall failures are present on the right side, one at Durling Road (Photo 6), the other of few hundred feet downstream near station 238+00. Each is about 200 feet long, 60 feet high, with average grades of 83%, and becoming steeper at the top. There is no rock cover on these barren clay-rich till slopes. The opposite left bank has a point bar on the inside of a bend. This large, lightly vegetated point bar and the following, previously absent, mid-channel bar may be due to excess sediment from the valley wall failures.

Photo 6: Bank failure site on the right bank at the end of Durling Road (facing downstream).

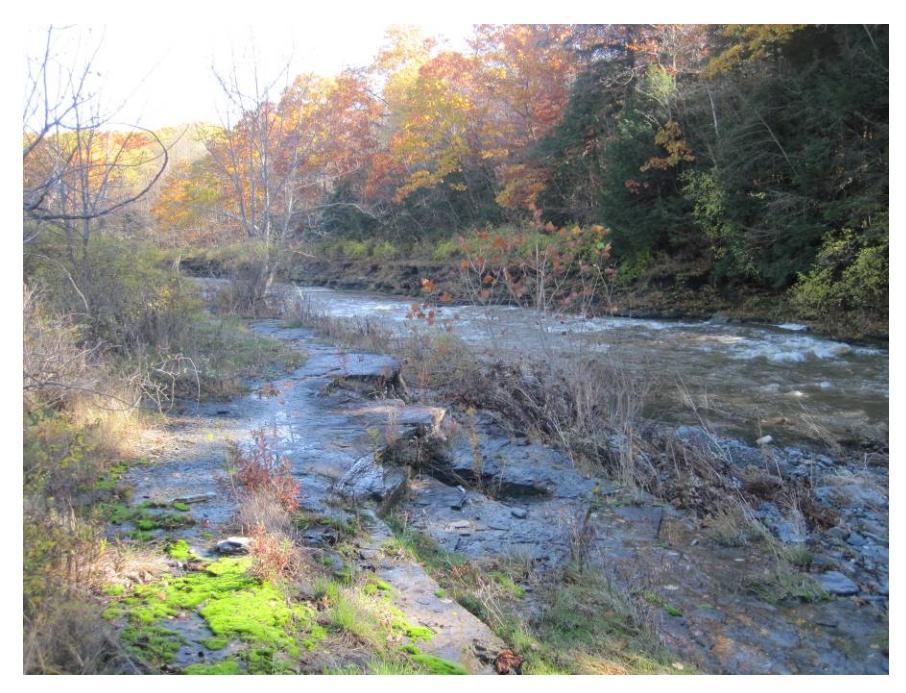
This entire river segment runs parallel to Taughannock Park Road within the state park. The channel is slightly incised into bedrock, is fairly straight, and is a fast run with occasional rapids (Photo7). The stratified rock provides a flat flume bed in some reaches. The channel is semiconfined on the right, while the left bank provides informal public access. The Rosgen classifications are type F1 and type B1.

Photo 7: Slightly incised, straight bedrock Channel typical in Segment #5 (facing downstream).

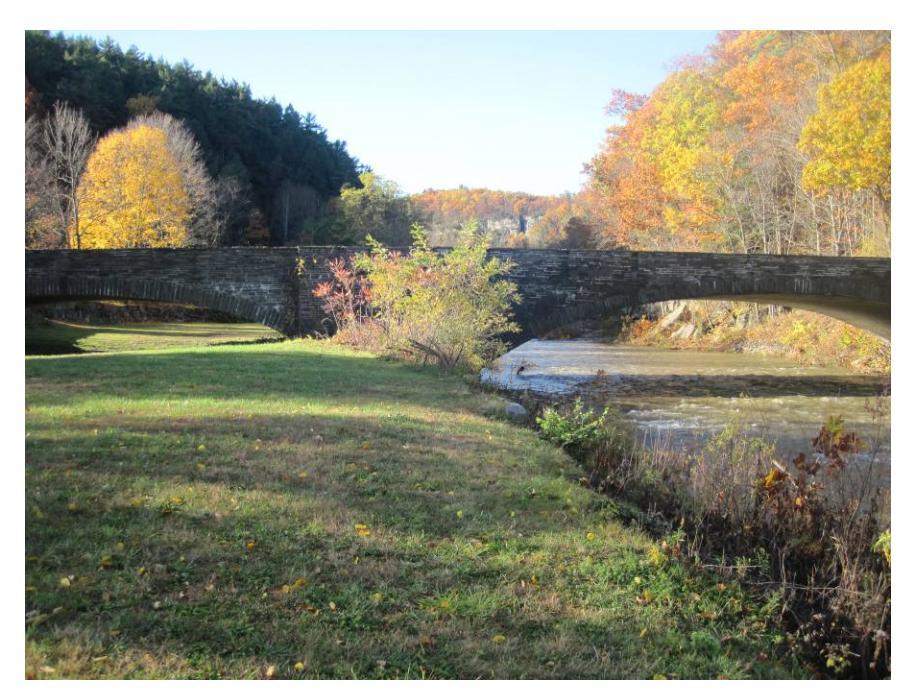
The Route 89 Bridge is a twin span arch structure in good visual condition. It is a concrete structure with a stone façade (Photo 9). One span is over the river, the other over a park lawn floodplain. The channel lined with stone walls is 100-feet wide. The water entering the lake was very turbid with poor visibility.

Photo 9: Route 89 Bridge showing turbidity in main channel (facing upstream).

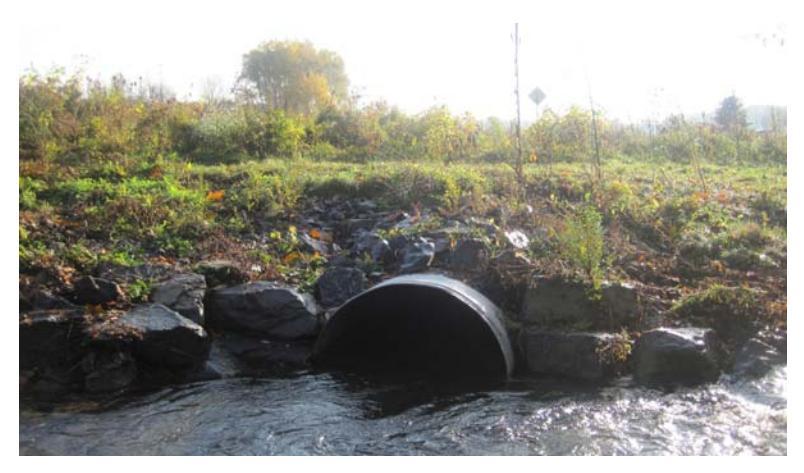
Photo 10: Direct conveyance of runoff into Taughannock Creek from nearby roads and farm fields.

Continued effort is needed to work with local farmers in the direct drainages to implement agriculture best management practices (BMPs) to naturalize land cover and field hydrology. Land use conversion on regularly inundated areas as well as direct drainage of turbid runoff from agricultural fields is a threat to water quality in the Taughannock Creek and Cayuga Lake. Additionally, adjusting cropping plans based on field inundation (i.e., changing the wettest areas from corn to hay), cover cropping, conservation tillage, injection spreading, row cropping, and other practices should be discussed with farmers to reduce nutrient-rich runoff.

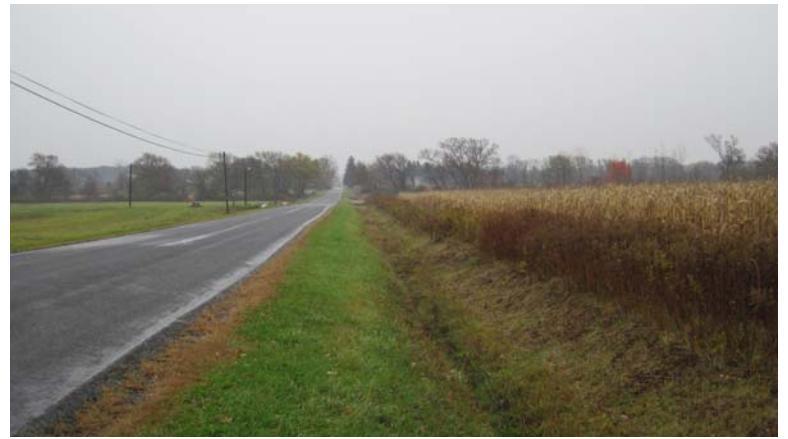
Photo 11: Vegetated agricultural ditch conveying runoff to a nearby stream.
