WATERSHED NEEDS ASSESSMENT

TAUGHANNOCK CREEK TOMPKINS COUNTY, NEW YORK

April 13, 2011

MMI #4395-01

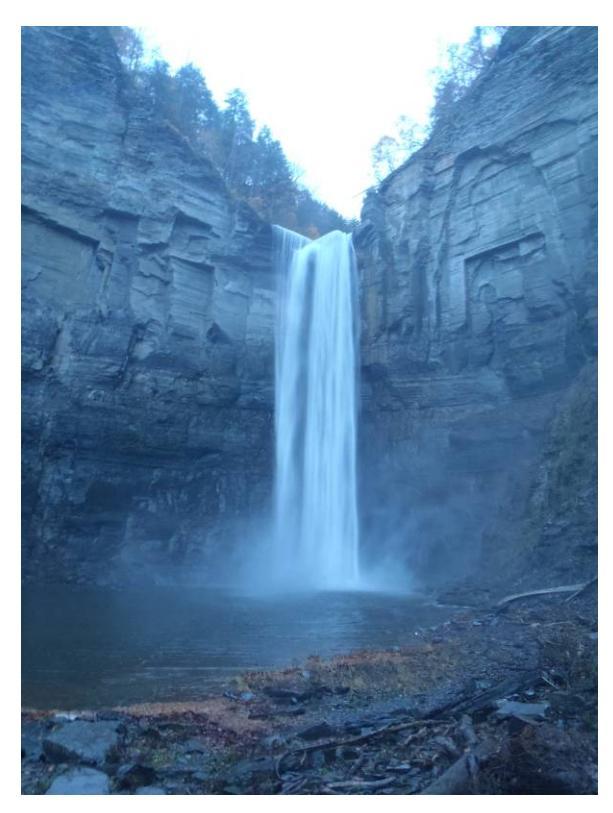
Photo 8: Taughannock Falls.

Segment #6 includes the large falls and the subsequent gorge to Route 89, all within the state park. The falls have a single drop, reportedly 215 feet, higher than Niagara Falls. It is the result of a hanging valley created when glaciers scoured the receiving valley that is now Cayuga Lake. The gorge has vertical walls up to 400 feet high and lacks till soil, indicating that it is postglacial and up to 10,000 years old (Photo 8).

Von Engeln (1961) reports the floor of the wide gorge is limestone, evident by its many solution pocketed surfaces. The sides of the lower gorge are composed of a dark shale and are subject to failures and rock falls, one of which was observed. The cap rock at the falls is sandstone.
